Hydrology of a Southern Appalachian Hypocrene Spring-Fed Fen

Garland Seep is a Southern Appalachian fen that supports a population of federally endangered green pitcher plants (*Sarracenia oreophila*). The wetland is underlain by clayey stream deposits above fractured bedrock, is located at the base of a mountain slope, and is fed by groundwater that originates as recharge on the adjacent hillslope. Groundwater wells were installed following a hydrologic restoration in the mid-1990s and have been monitored at varying frequencies since that time. The 20+ year record provides evidence that Garland Seep can be classified as a “hypocrene fen,” in which spring flow rarely reaches the ground surface because of low discharge rates and high evapotranspiration (ET). In general, water-level fluctuations followed seasonal ET patterns, with higher water levels in the winter and early spring (when ET is low) and lower levels in the summer and fall. During wetter years, the water table remained near the ground surface for much of the year, with the clay layer underlying the site retaining moisture even after water levels had dropped. The “clay wetting” period was shorter during dryer years and

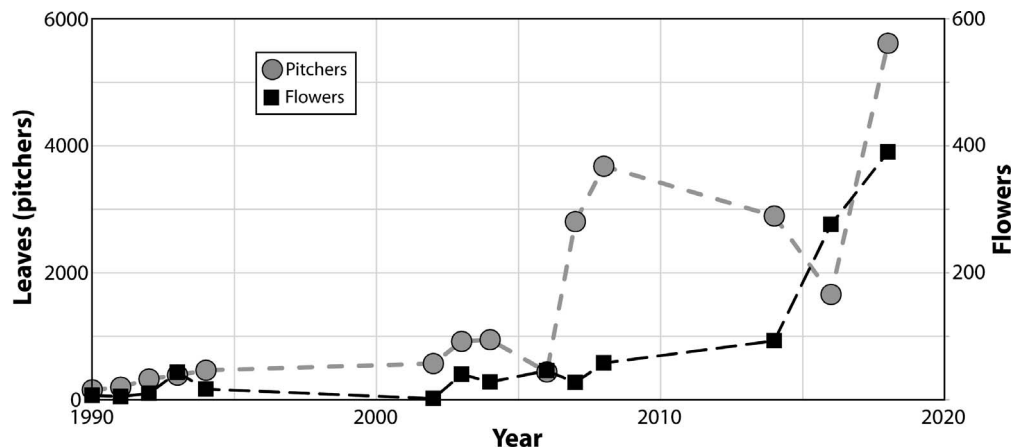
Figure 4. The Nature Conservancy has documented an increase in the number of *Sarracenia oreophila* leaves (pitchers) and flowers along three survey transects (TNC, 2010).

TNC has actively managed Garland Seep since the early 1990s and has documented a dramatic increase in *Sarracenia* clumps, pitchers, and flowers (Figure 4). While there may be several contributing factors to the success of TNC management, the recognition of Garland Seep as a hypocrene spring provides a hydrologic mechanism with which to explain the thriving *Sarracenia* population. First, TNC recognized that drain tiles running below the site were likely drying the wetland. The manner in which the drain tiles functioned, though, turned out to be unusual: rather than draining excess water downward from the soil surface, as in a typical wetland, the tiles instead intercepted artesian flow before it could reach the shallow soil or ground surface above. Plugging the drain tile outlets and excavating the gravel beds around the tiles had the effect of allowing more water to reach the root zone.

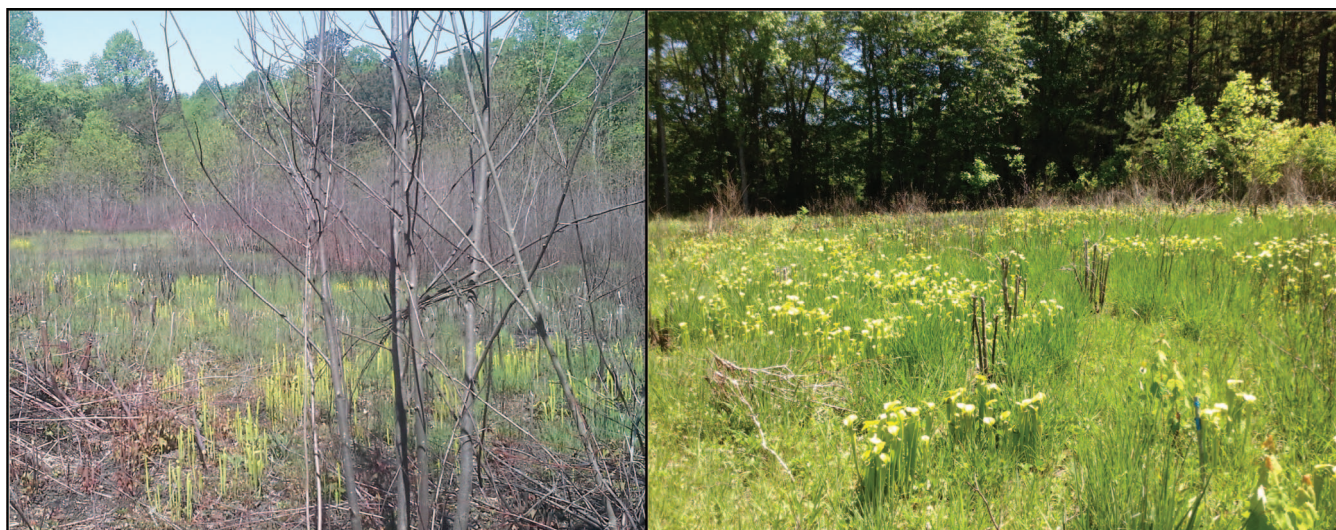
Figure 8. New *Sarracenia oreophila* leaves on May 1 (left) and May 22 (right) following 29 March 2015 prescribed fire.

TNC also recognized the historic importance of fire at Garland Seep and has burned the site every 2 to 5 years since re-introducing controlled fire in 1992 (see markers at the top of Figure 7). The greatest observed hydrologic impact of these fires followed a prescribed burn on 29 March 2015. When we returned to the site on 1 May 2015, we observed standing water at the ground surface and thousands of new pitcher leaves (Figure 8). Precipitation had been below average every month so far that year, and the rise in water levels following the burn was unmistakable (see wells 1 and 14 in Figure 7). The obvious explanation is that the burn reduced ET (at least initially) and allowed upwelling groundwater to reach the surface. The reasons for which the 2015 prescribed fire had such clear effects on ET and water levels compared to those conducted previously are not as obvious. Looking at the historical record, standing water would have also been observed in the vicinity of well 1 following burns in 1997, 2005, 2009, and 2011. These burns coincided with relatively wet years—years in which P-ET exceeded 20 in. (50 cm)—but none resulted in such a significant or long-lasting rise in water levels as observed in 2015. TNC had recently hired a new stewardship manager prior to the 2015 burn, and the firing techniques may have been different than when TNC relied on partners to lead burns. The new manager also emphasized aggressive removal of competing hardwoods, which would have reduced overall ET and possibly intensified the impact of prescribed fire on the undergrowth. Perhaps the weather conditions simply allowed for a particularly effective burn. In any case, periodic prescribed fires at Garland Seep may help preserve the *Sarracenia* population by both keeping an open canopy and reducing ET to keep water levels near the surface.
